DEVELOPMENT OF A COMPUTERIZED DATA BASE TO MONITOR  
WHEELED VEHICLE CORROSION

OCTOBER 1989

Alfonso L. Baldi  
Edwin A. Crombie  
David P. Dillard  
Alloy Surfaces Company  
100 Locke Road  
Wilmington, Delaware 19809

I. C. Handsy  
U.S. Army Tank-Automotive Command  
ATTN: AMSTA-RSM  
Warren, MI 49397-5000

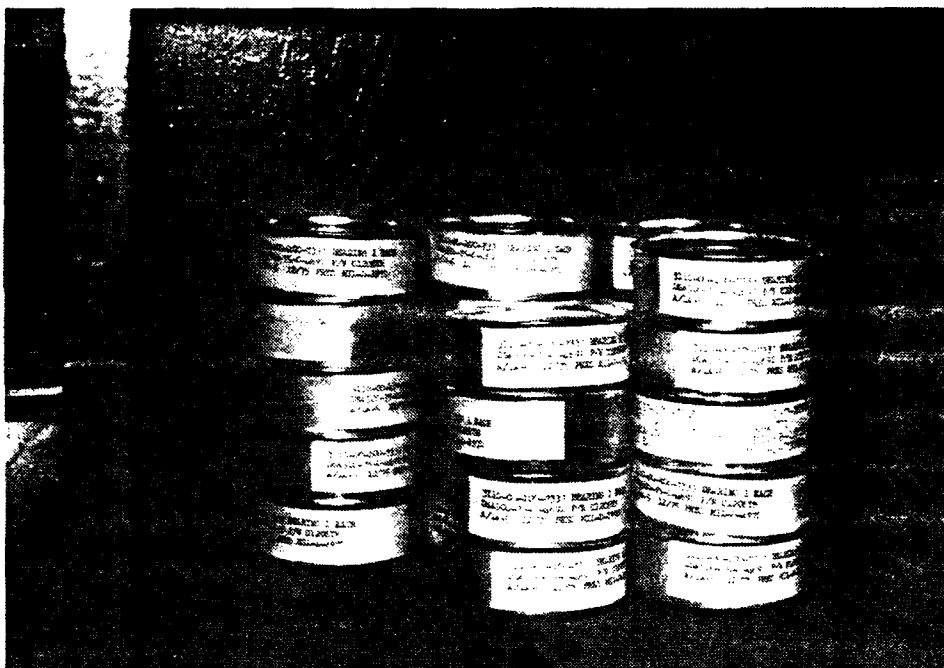
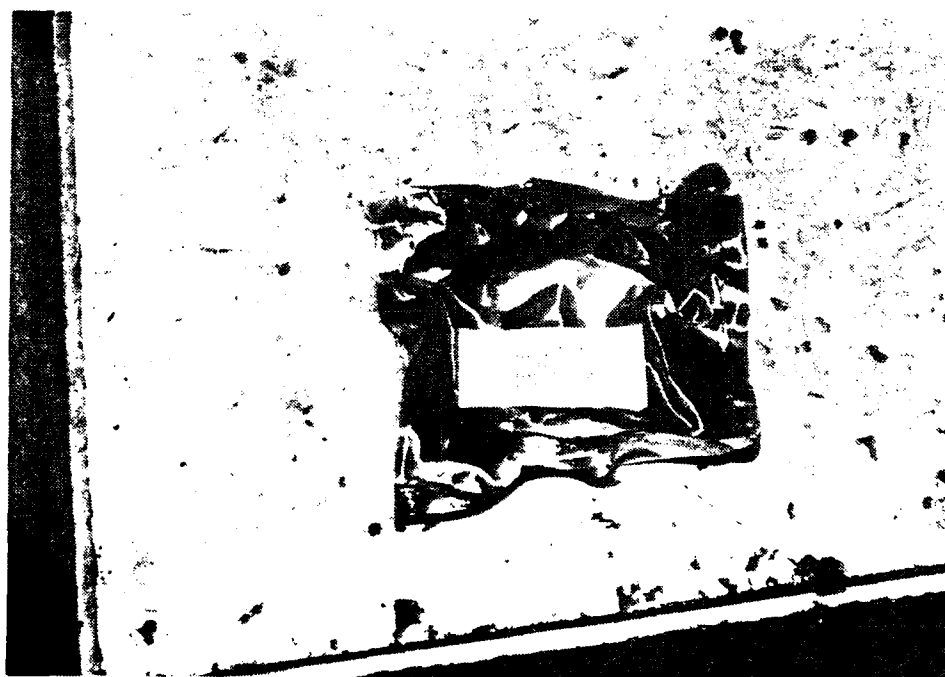
Figure 5.9-3. Sealed Cans or Pouches

reduced amount of storage space was in many cases insufficient for the amount of inventory involved. Consequently, several "space-saving" techniques were employed, several of which are not conducive to component corrosion protection.
